# CITY OF POULSBO

## Contribution to Puget Sound Recovery

# HIGHLIGHTS

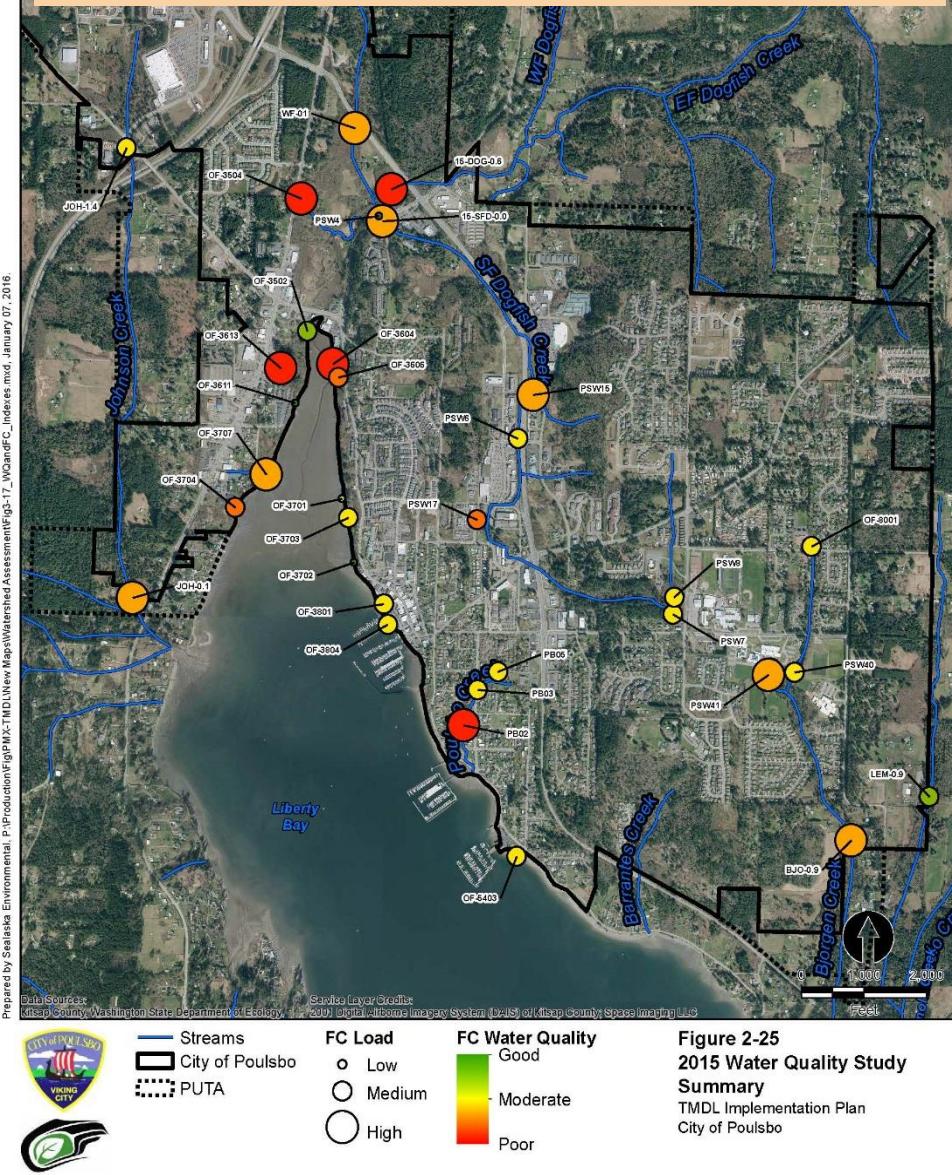
**Figure 2-25  
2015 Water Quality Study  
Summary  
TMDL Implementation Plan  
City of Poulsbo**

# Synoptic Stormwater Sampling

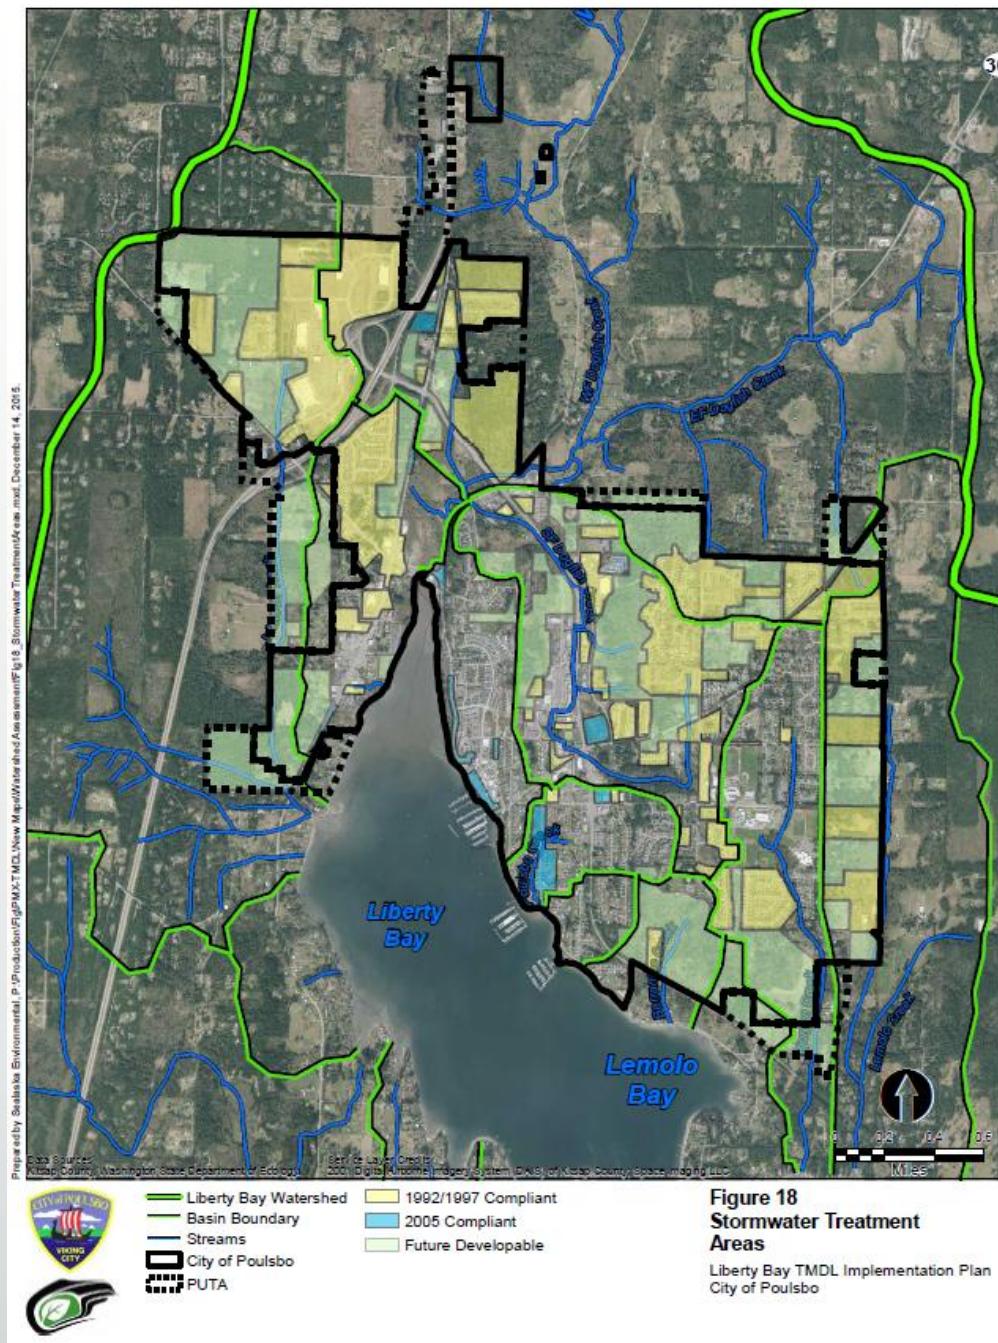
# Stormwater Treatment and Impervious Areas

- > 50% of the Total Impervious Area is Treated

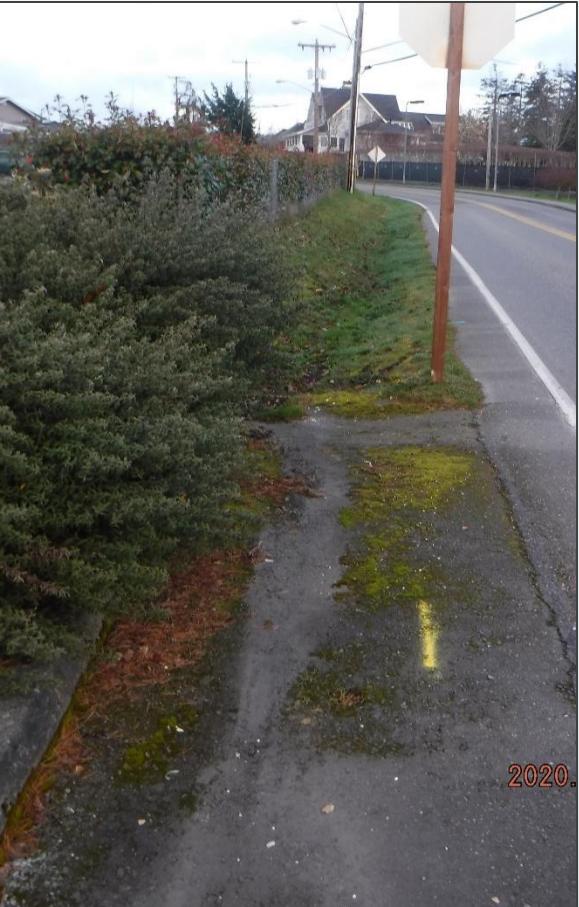
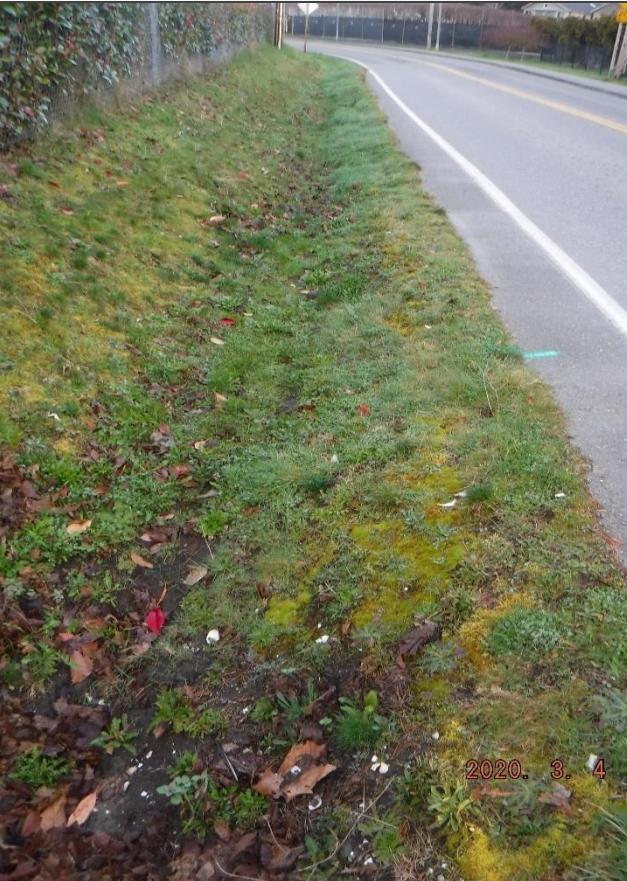
# Fjord Drive Bioretention Swale - Before

- Existing condition is a roadside grass lined ditch
- No water quality treatment
- Mud / sedimentation build up

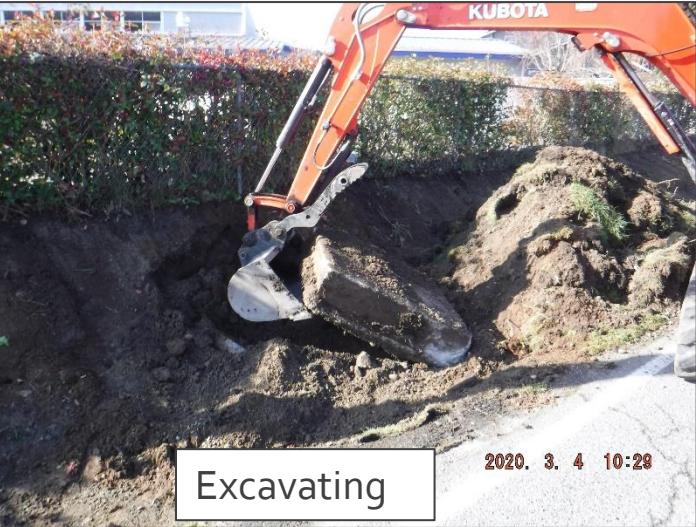
Excavating

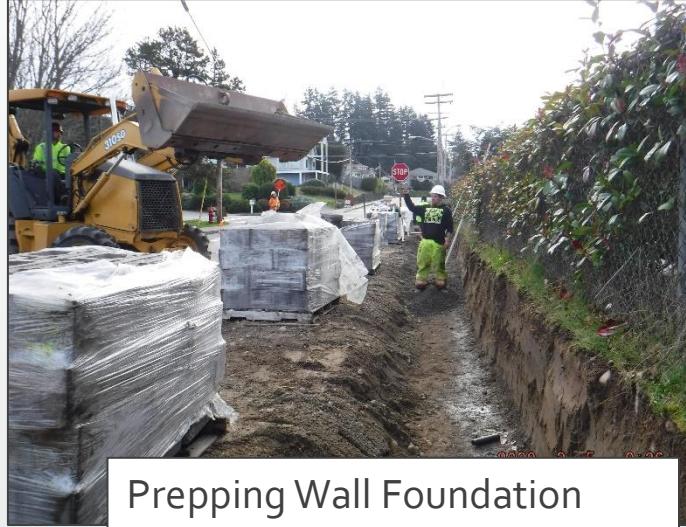
Prepping Wall Foundation

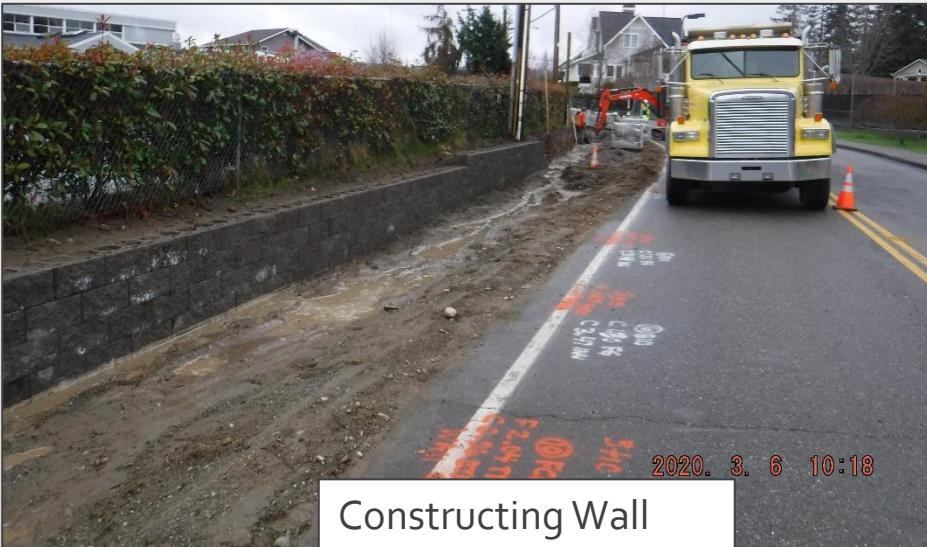
Constructing Wall

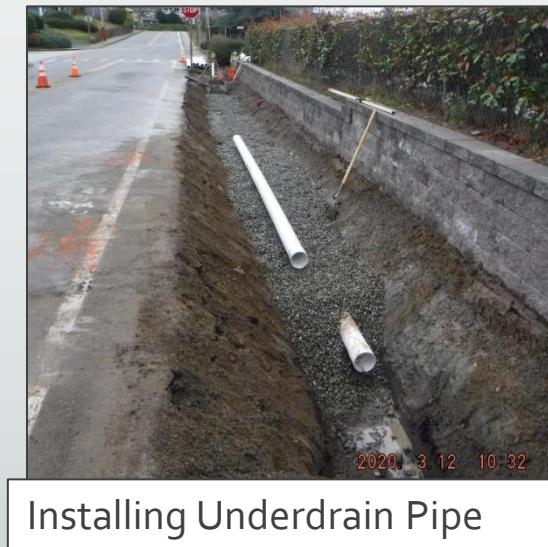
Installing Underdrain Pipe

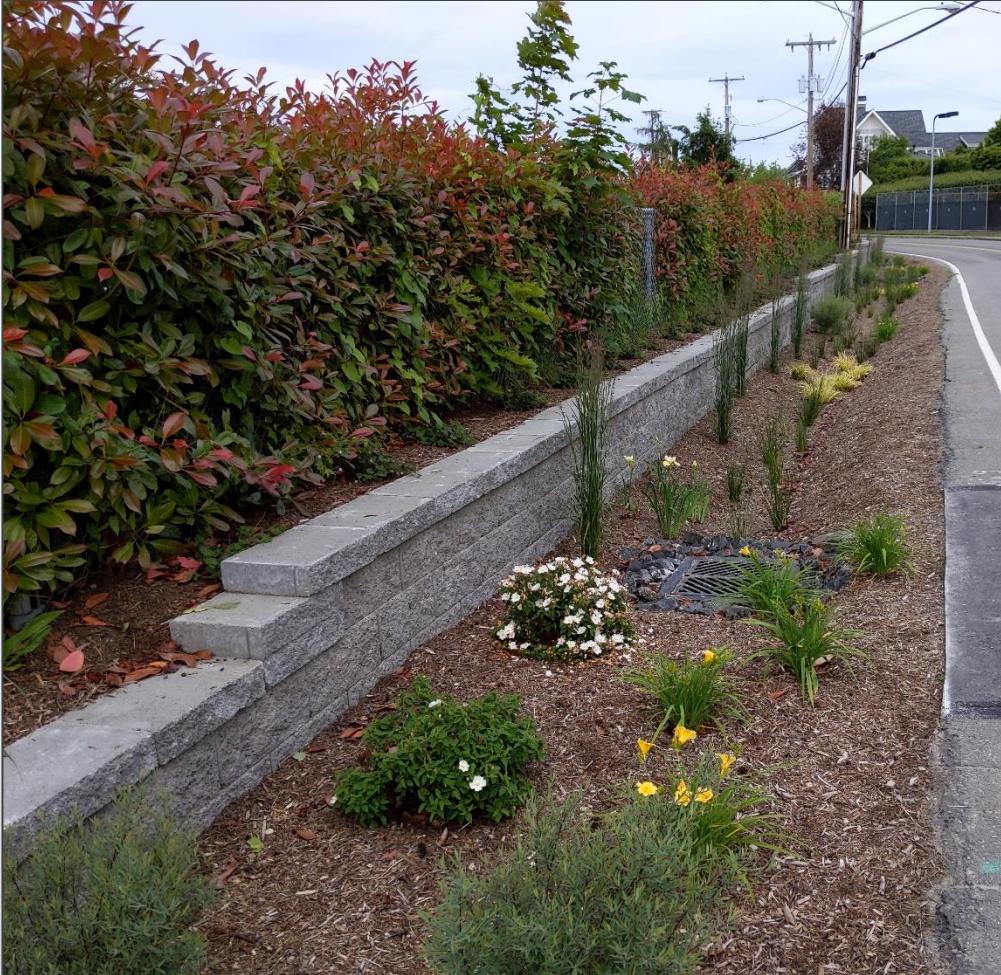
# Fjord Drive Bioretention Swale – Complete

- Enhanced Water Quality Treatment ~ 1.4 Acres
  - 0.6 Acres of road surface
- Attractive retrofit
- Consistent with LID features in downtown, on 6<sup>th</sup> Ave, and on Hostmark

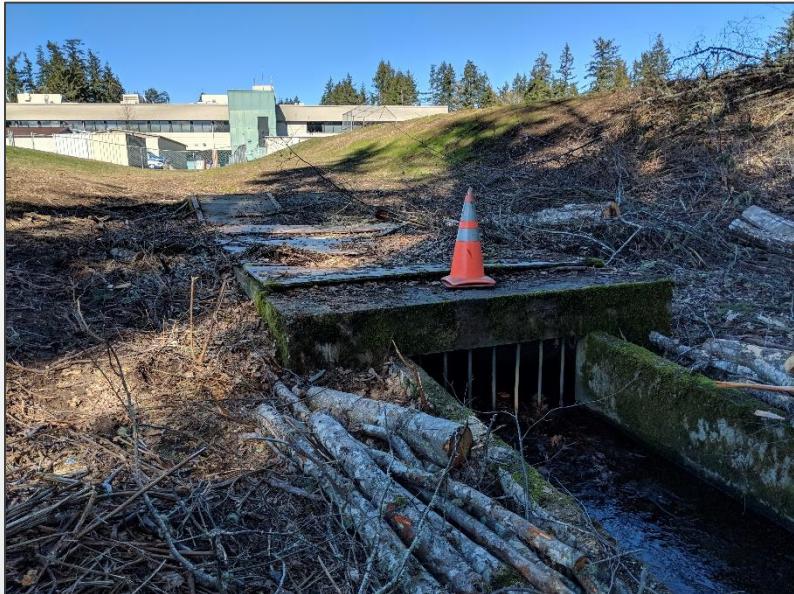
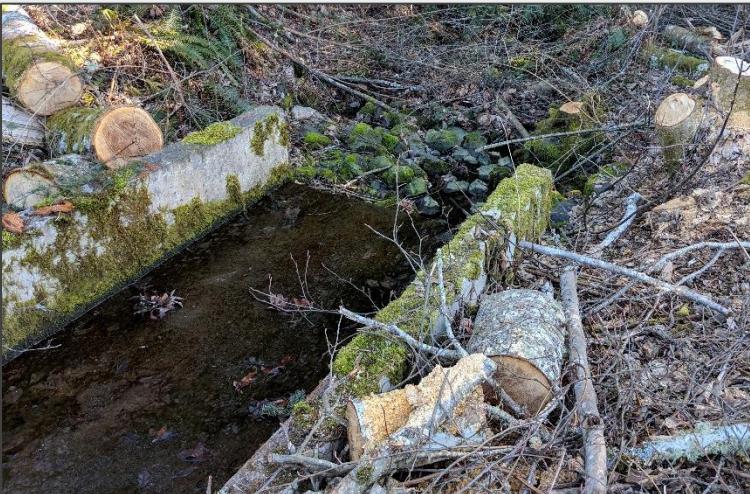
# Poulsbo Middle School Water Quality Vault - Before

- Outfall for ~115 Acre basin
- No treatment
- Large concrete outfall structure in degraded condition
  - Attractive nuisance
- Erosion/degradation of outfall near Creek

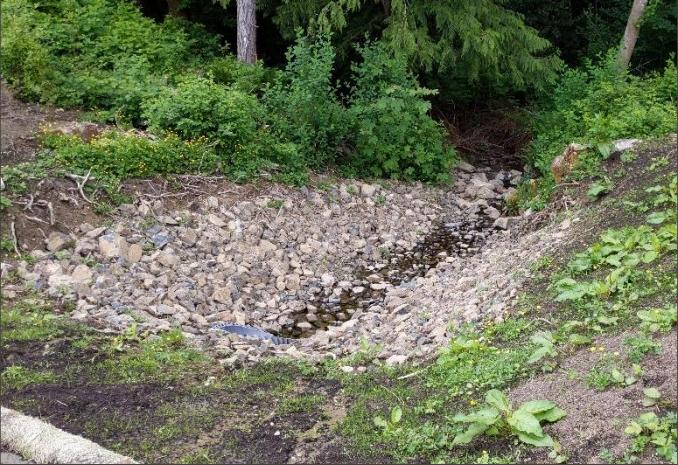
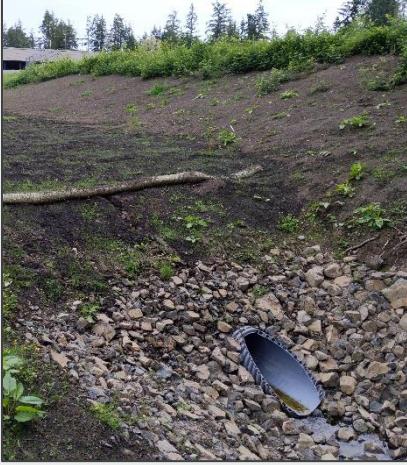
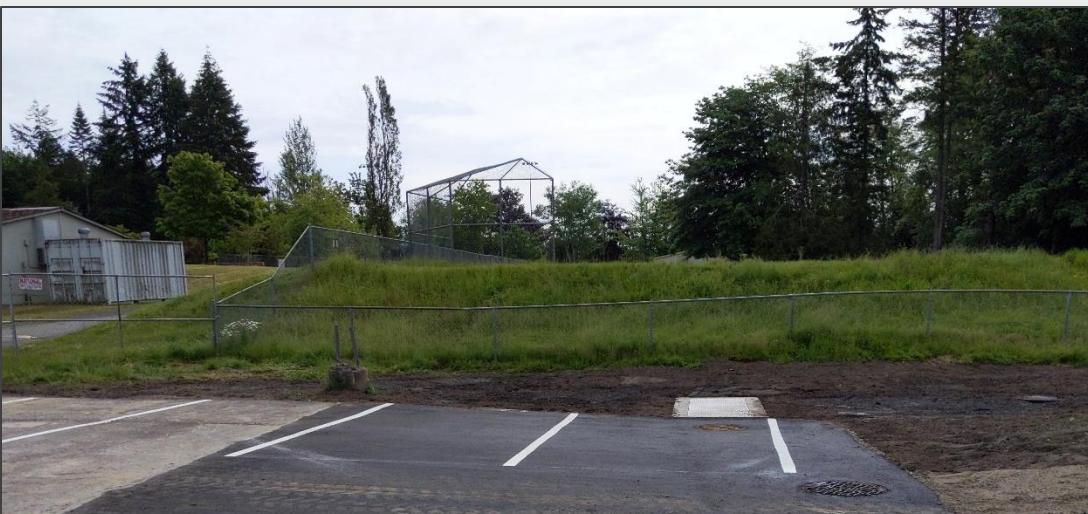
# Poulsbo Middle School Water Quality Vault—Complete

- Enhanced Water Quality Treatment ~ 2.56 Acres of PGIS
- Allows for School/City to install treatment vaults in line for increased capacity
- Stabilized outfall and placed farther back from Bjorgen Creek

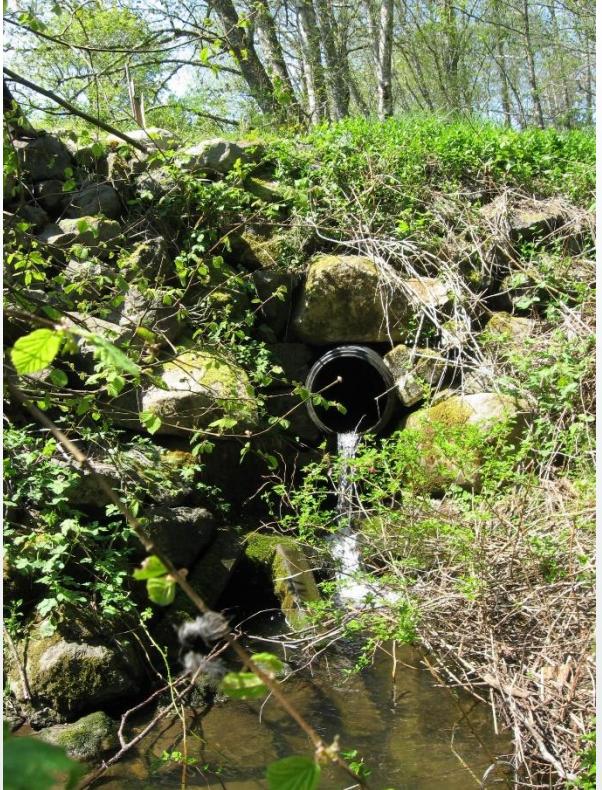
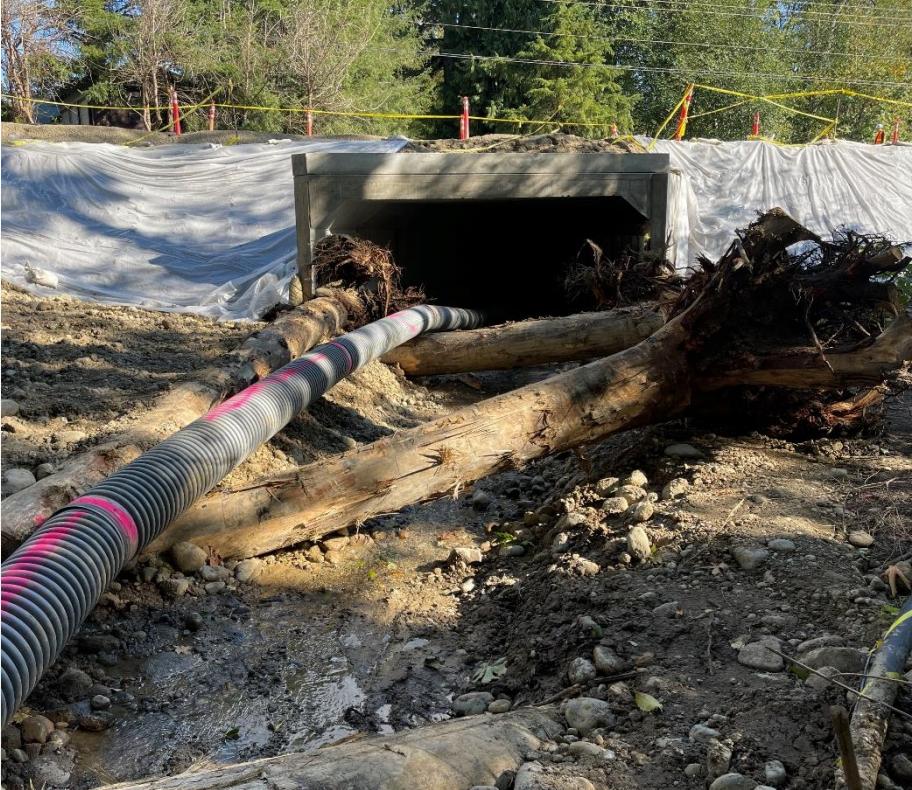
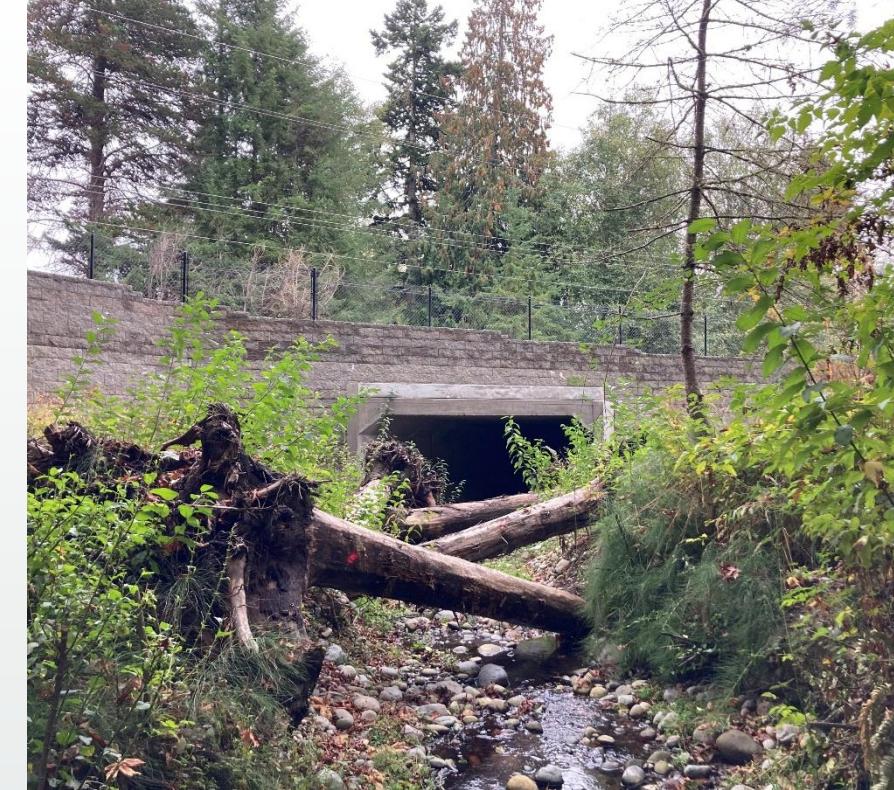
## BJORGEN CREEK

- Channel grade was too steep for fish
- Reconfigured to meet Dept. of Fish and Wildlife requirements.

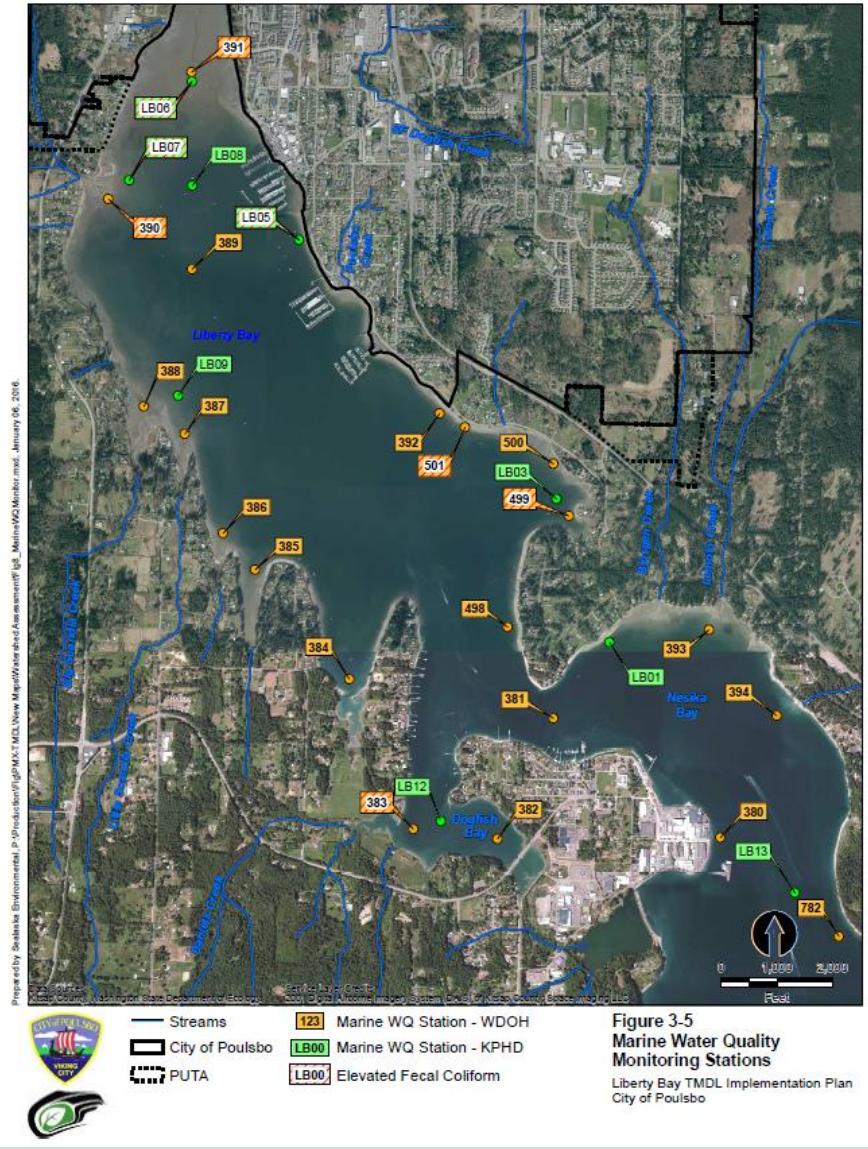
Figure 3-5  
Marine Water Quality  
Monitoring Stations

Water quality is improving.  
Marine water meets standards  
at all 29 locations.

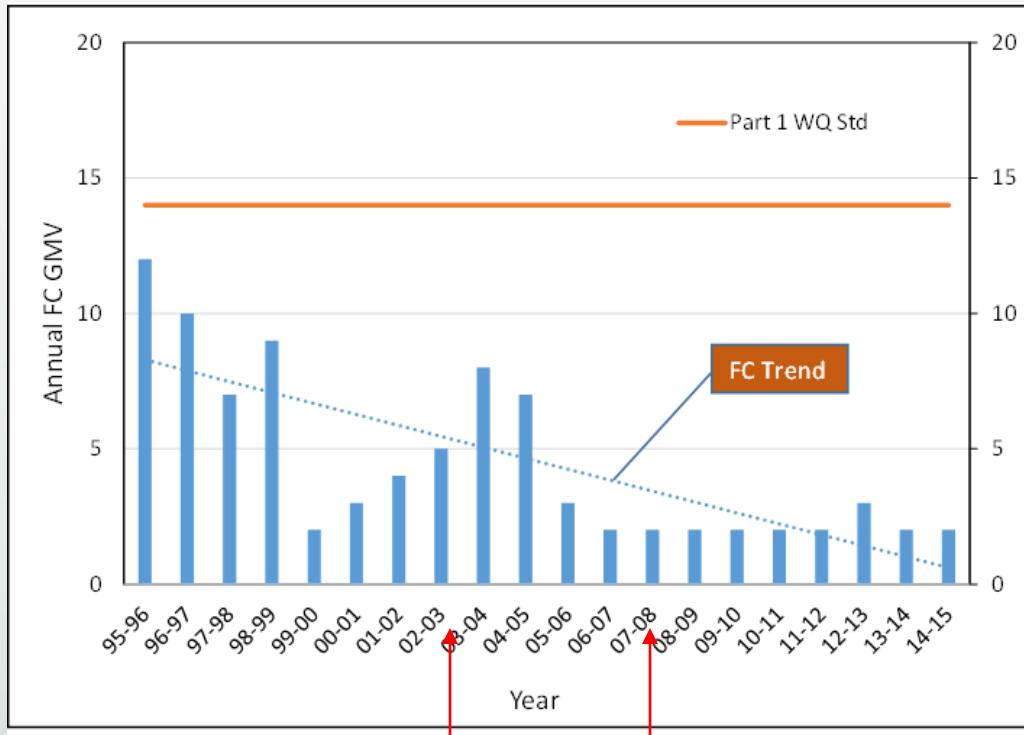
Figure 2-12. Trend for Liberty Bay Marine Station LB05

1<sup>st</sup> City retrofit

Regional PIC  
project
